A Selection of Technical Reports Submitted to The Aberfan Tribunal

A Selection of Technical Reports submitted to the Aberfan Tribunal

Geotechnical Investigation into the Causes and Circumstances of the Disaster of 21st October, 1966

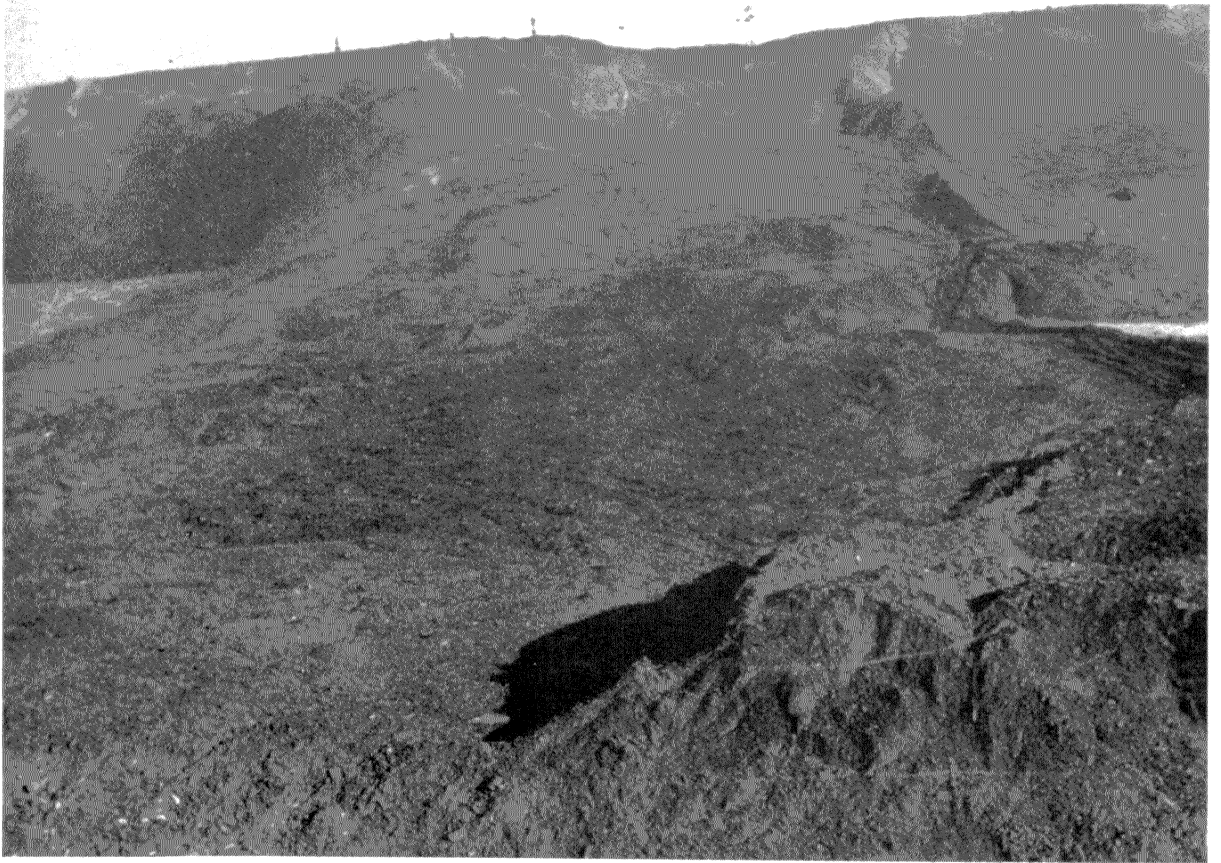
1.3 Flowslide at Abercynon, December 1939.

- (i) It took the form of a potentially destructive flow slide, although accompanied by no significant outflow of water. The gradient on which it flowed is much the same as at Tip 7 at Aberfan in 1966. The developed sections are compared in Fig. 1.2.

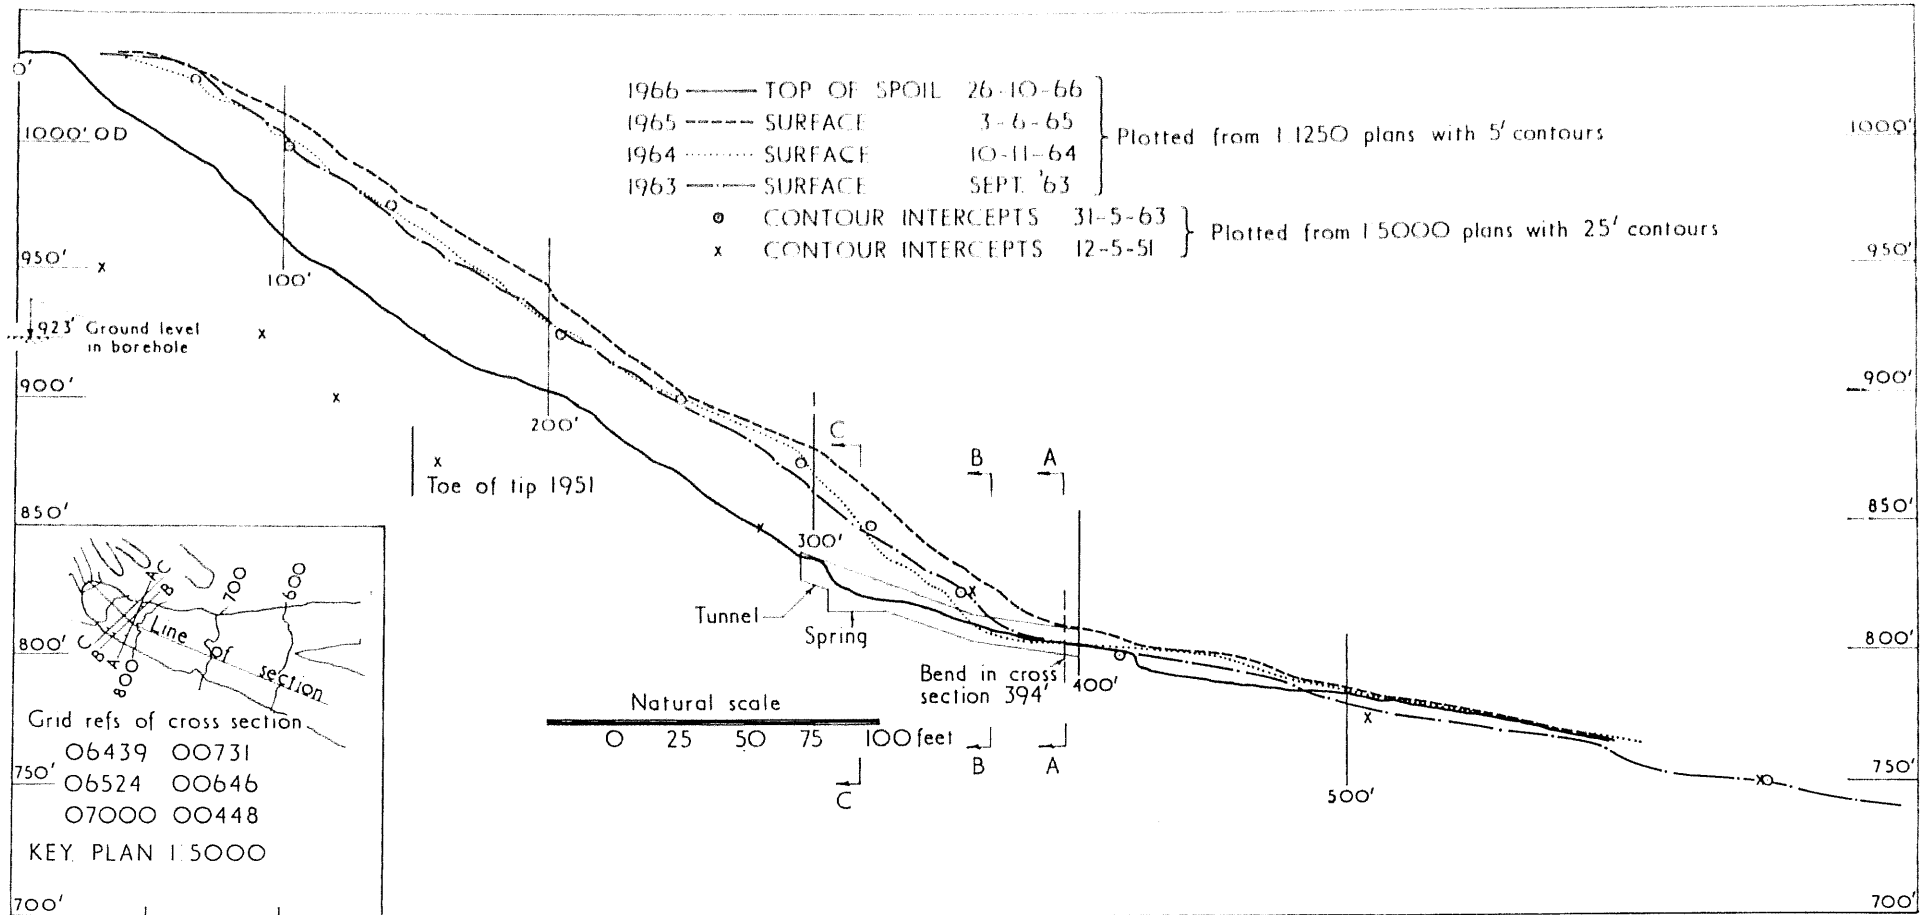
1.4a Agreed sections of Tip 7 for the years 1963–1966. Section through crest.

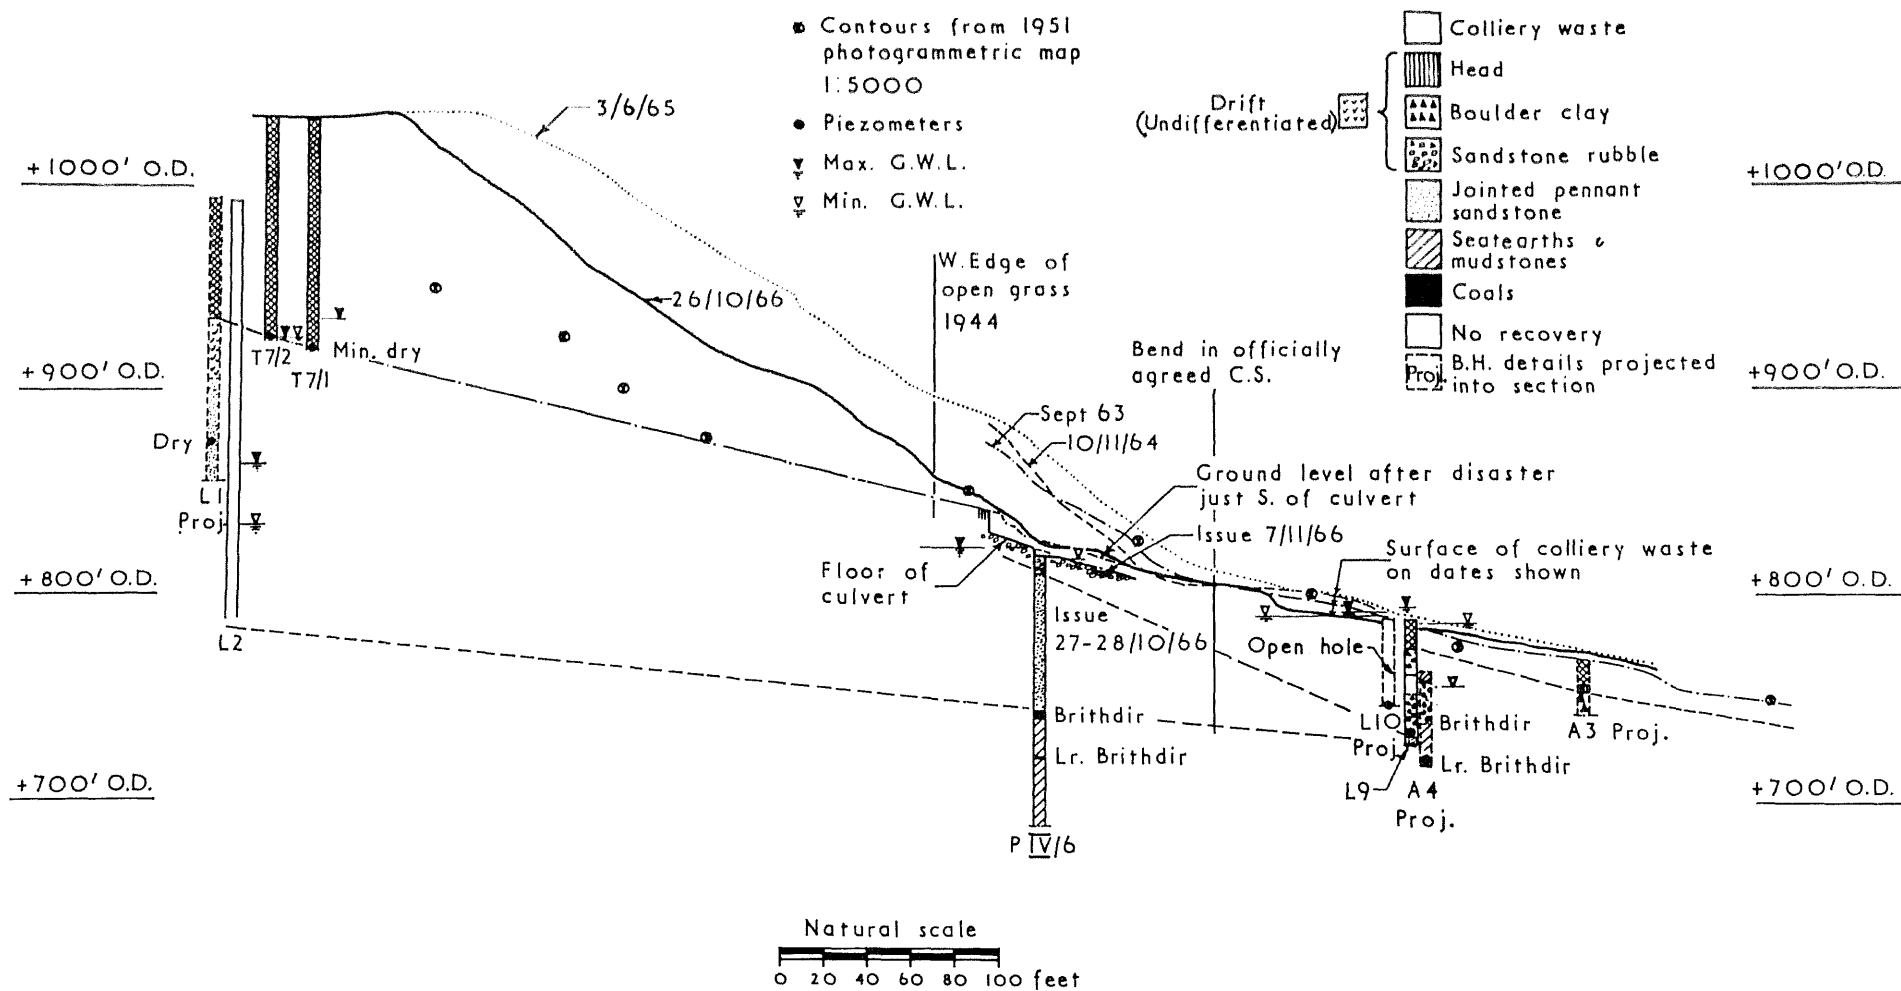
1.5 Down-slope section D-D through 'spring' at borehole PIV/6.

The conditions immediately downslope from the 'spring' are shown in more detail on the section of Fig. 1.5. Of particular interest is piezometer L9 which is installed at the base of the Sandstone Rubble and indicates an artesian ground-water pressure, with respect to the interface between the tip rubbish and the drift, which ranges from about 12 to 20 ft (–785.9 to –793.6 ft O.D.). Prior to the discharge of water associated with the disaster of October 1966 the ground-water pressures at this point are likely to have been greater than any pressures measured subsequently. The maximum piezometric level observed since the disaster, of –793.6 ft O.D., may be taken as a reasonable lower bound for the piezometric level immediately before the disaster at the position now occupied by piezometer L9.

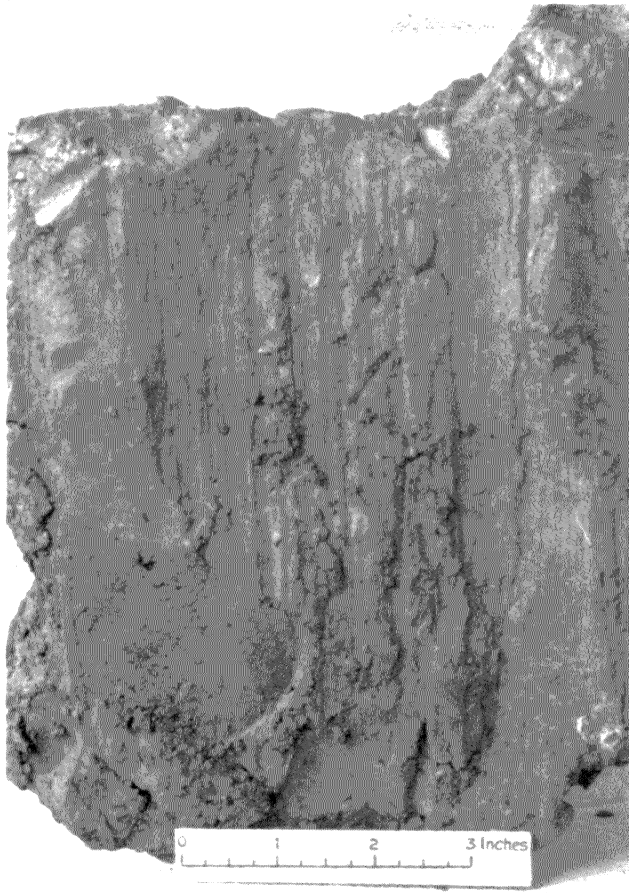
1.10 Photograph of samples showing polished and striated slip-surface.

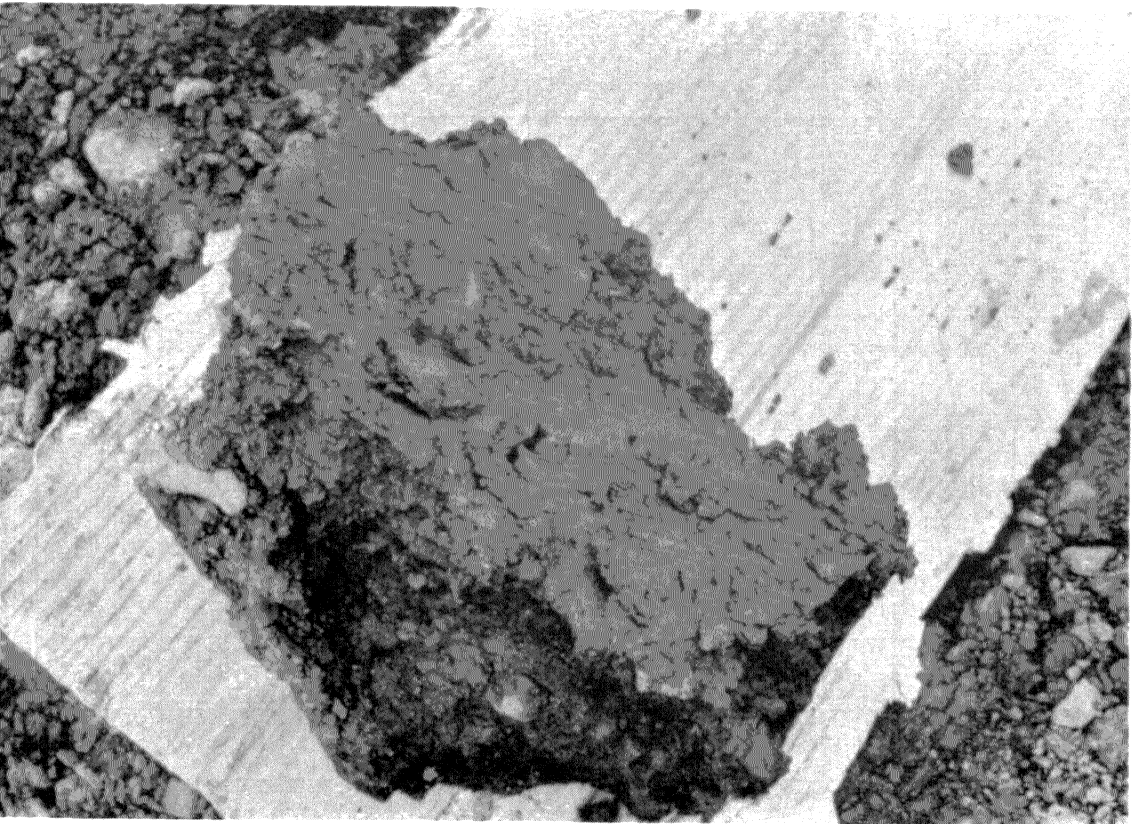
Colour transparency of a sample removed from above slip plane showing striations.

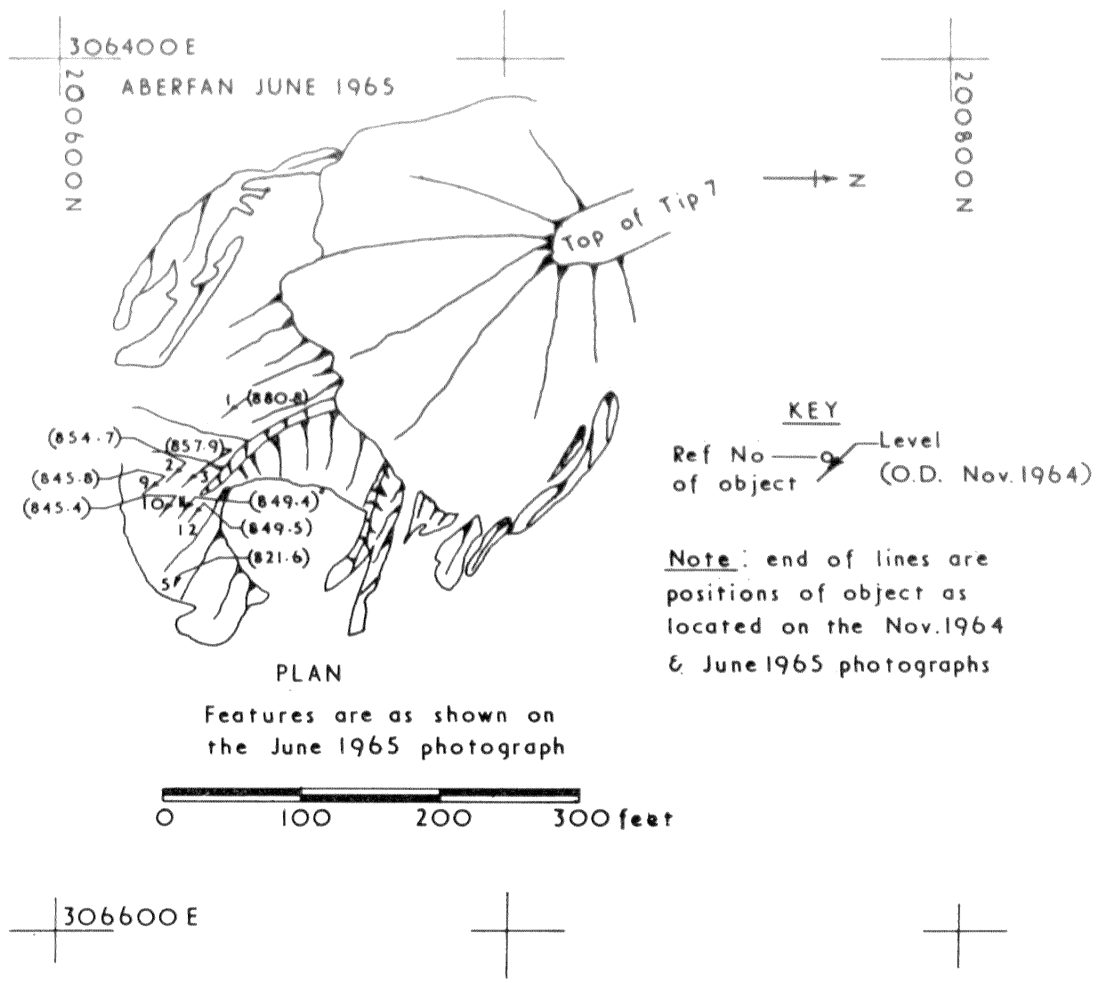
1.11 Plan showing movements of reference objects between November 1964 and June 1965.

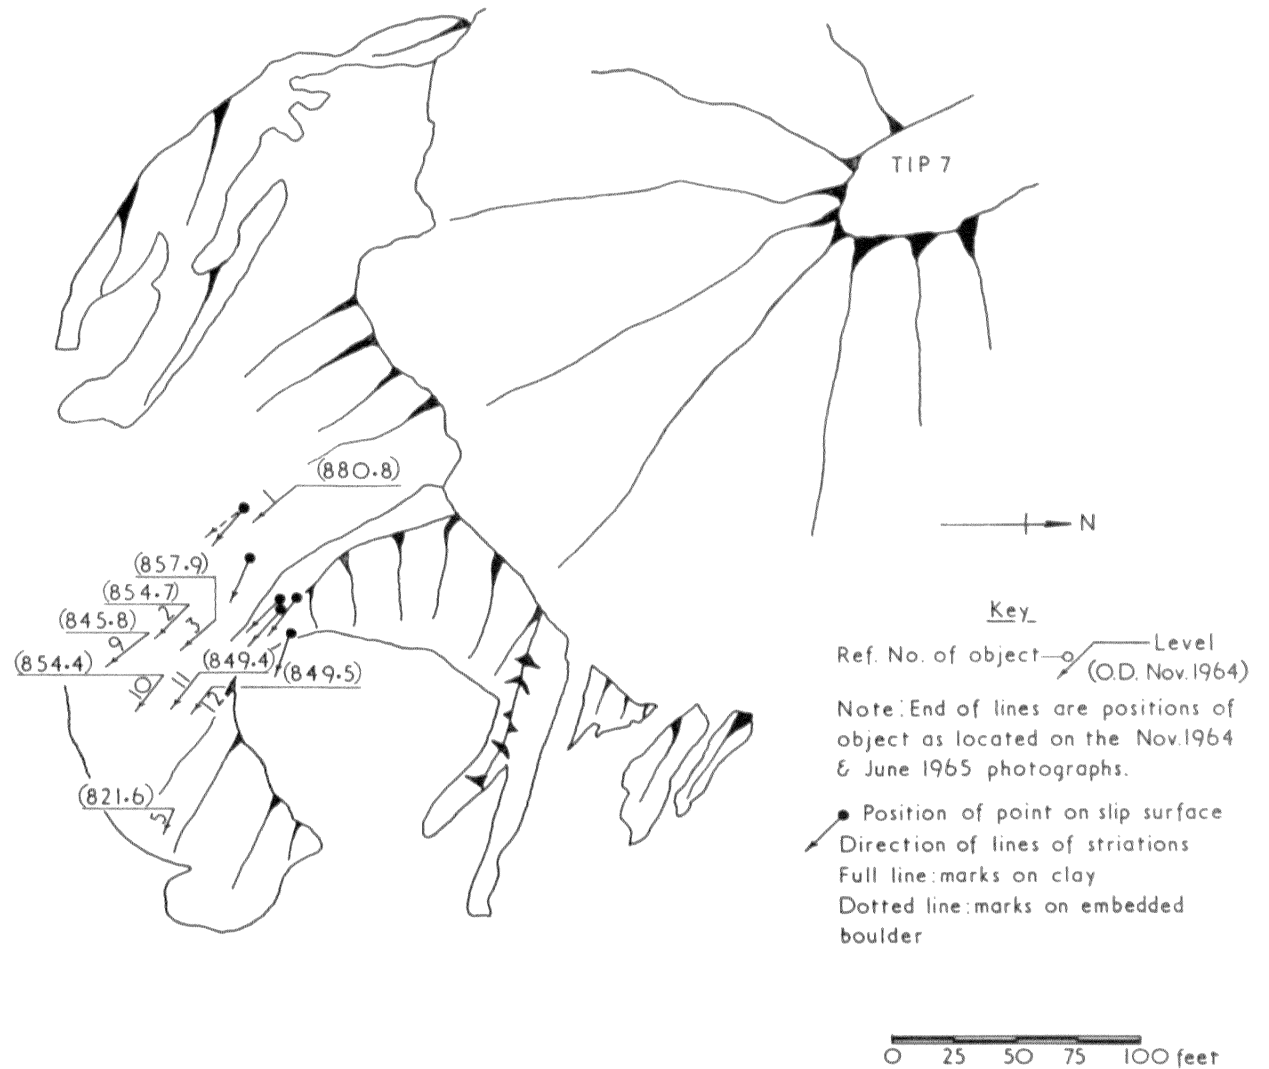
1.12 Plan showing movements of reference objects between November 1964 and June 1965 and showing direction of striations on slip surface exposed by excavation, February 1967.

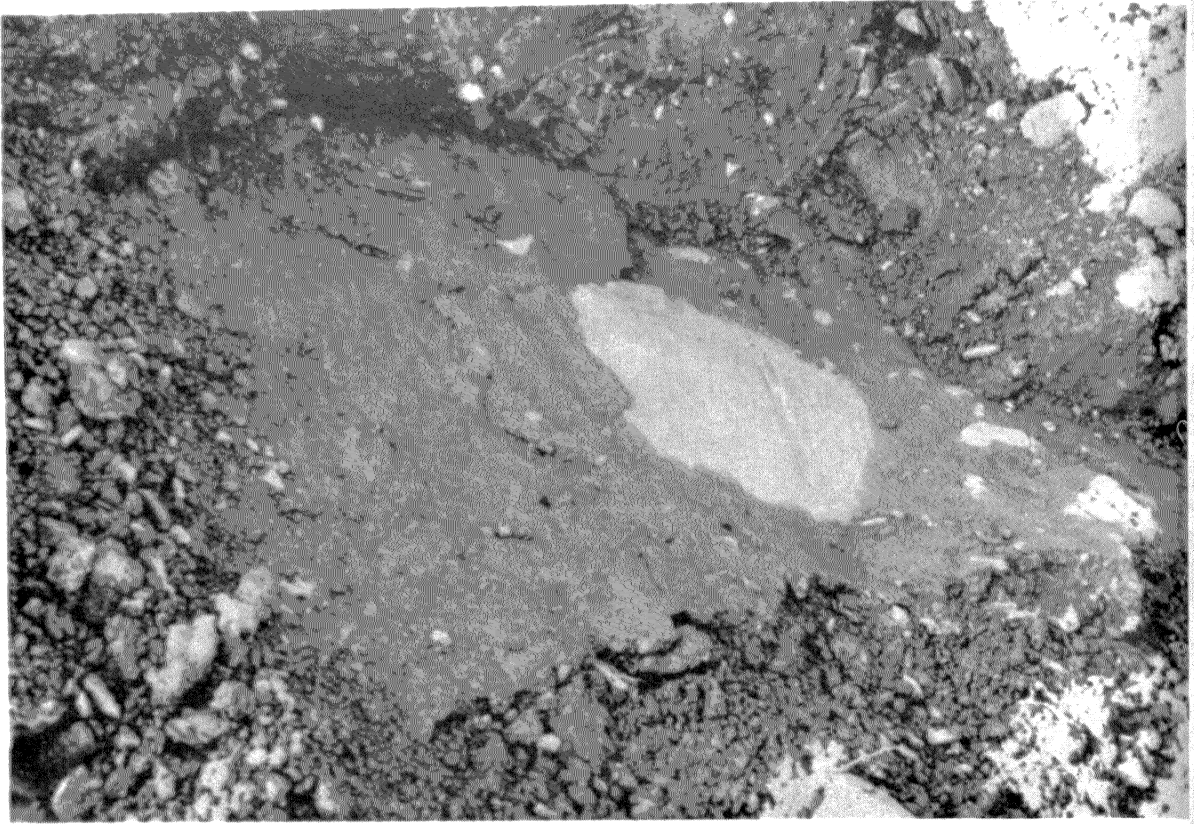
1.13* Colour transparency showing the embedded boulder with red pencil giving direction of striations.

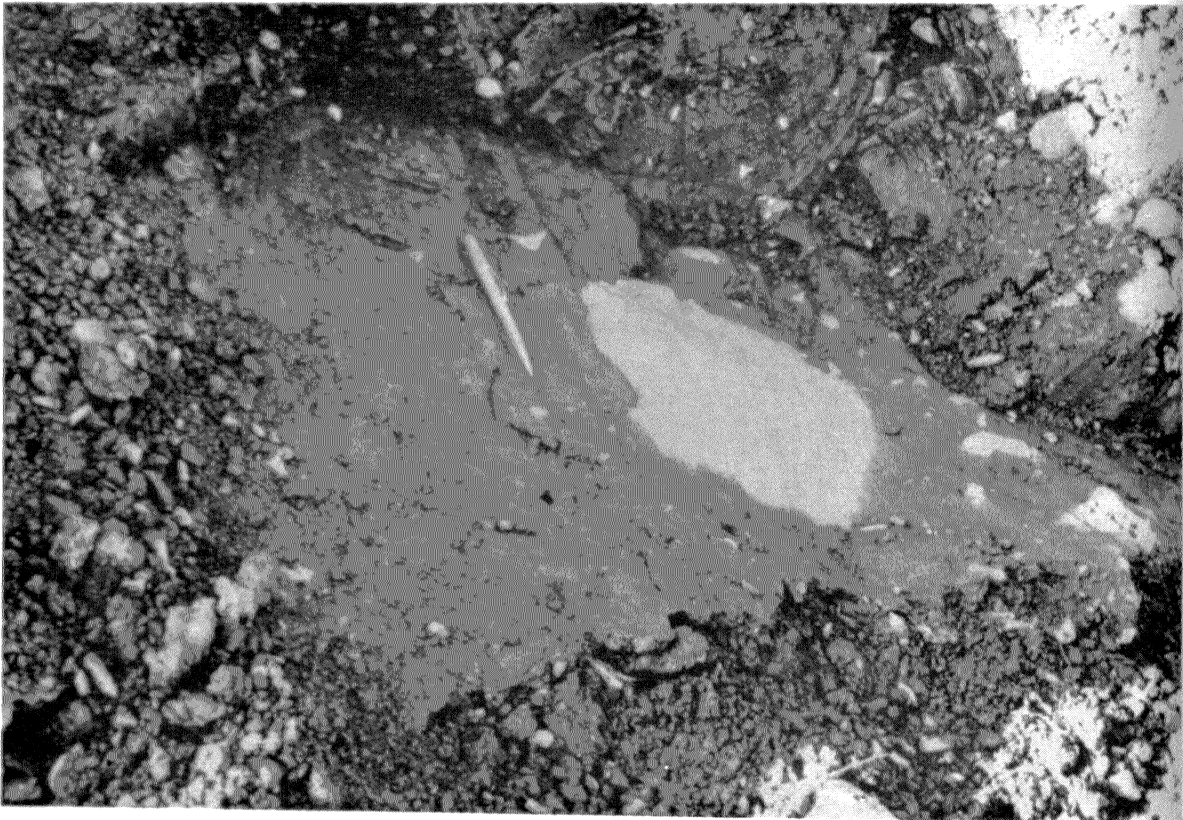
1.14* As Fig 13 with red pencil showing direction of striations on adjoining slip surface.

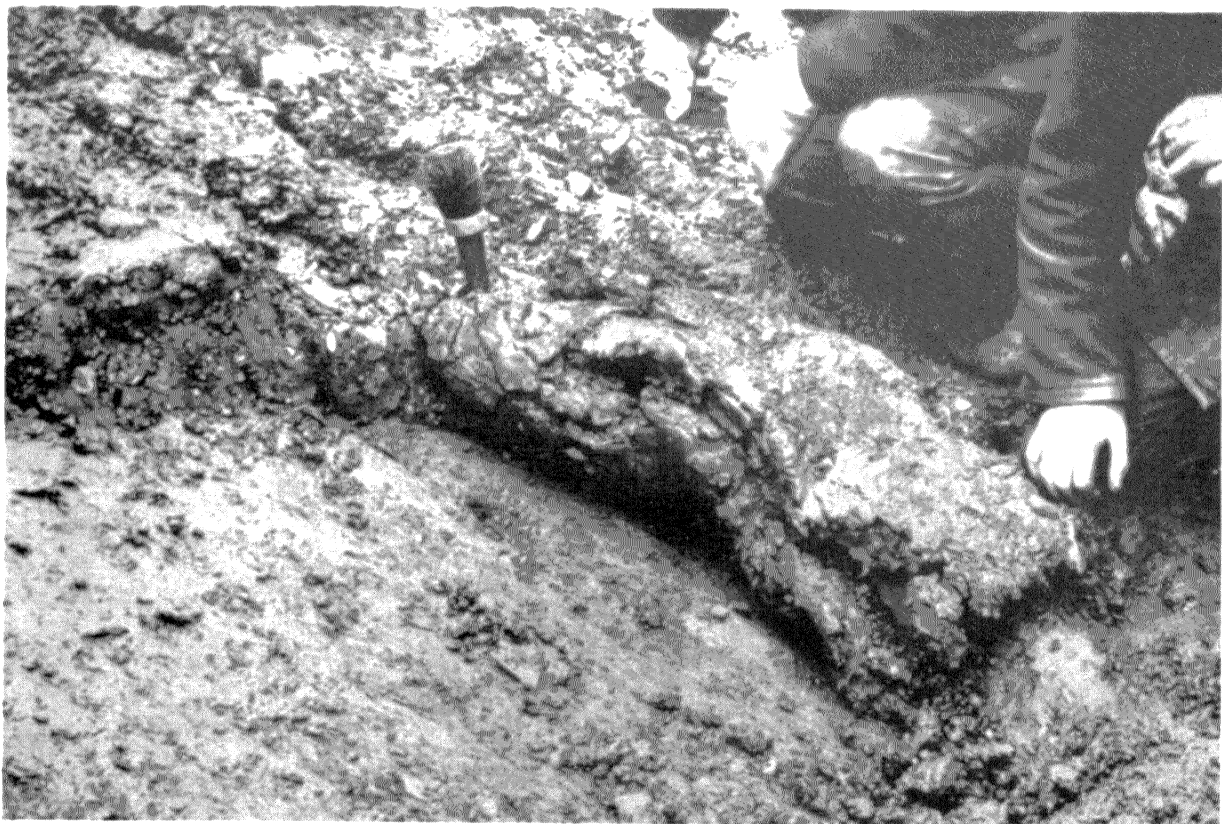
1.15* Colour transparency of slip plane exposed by rolling back material above it.

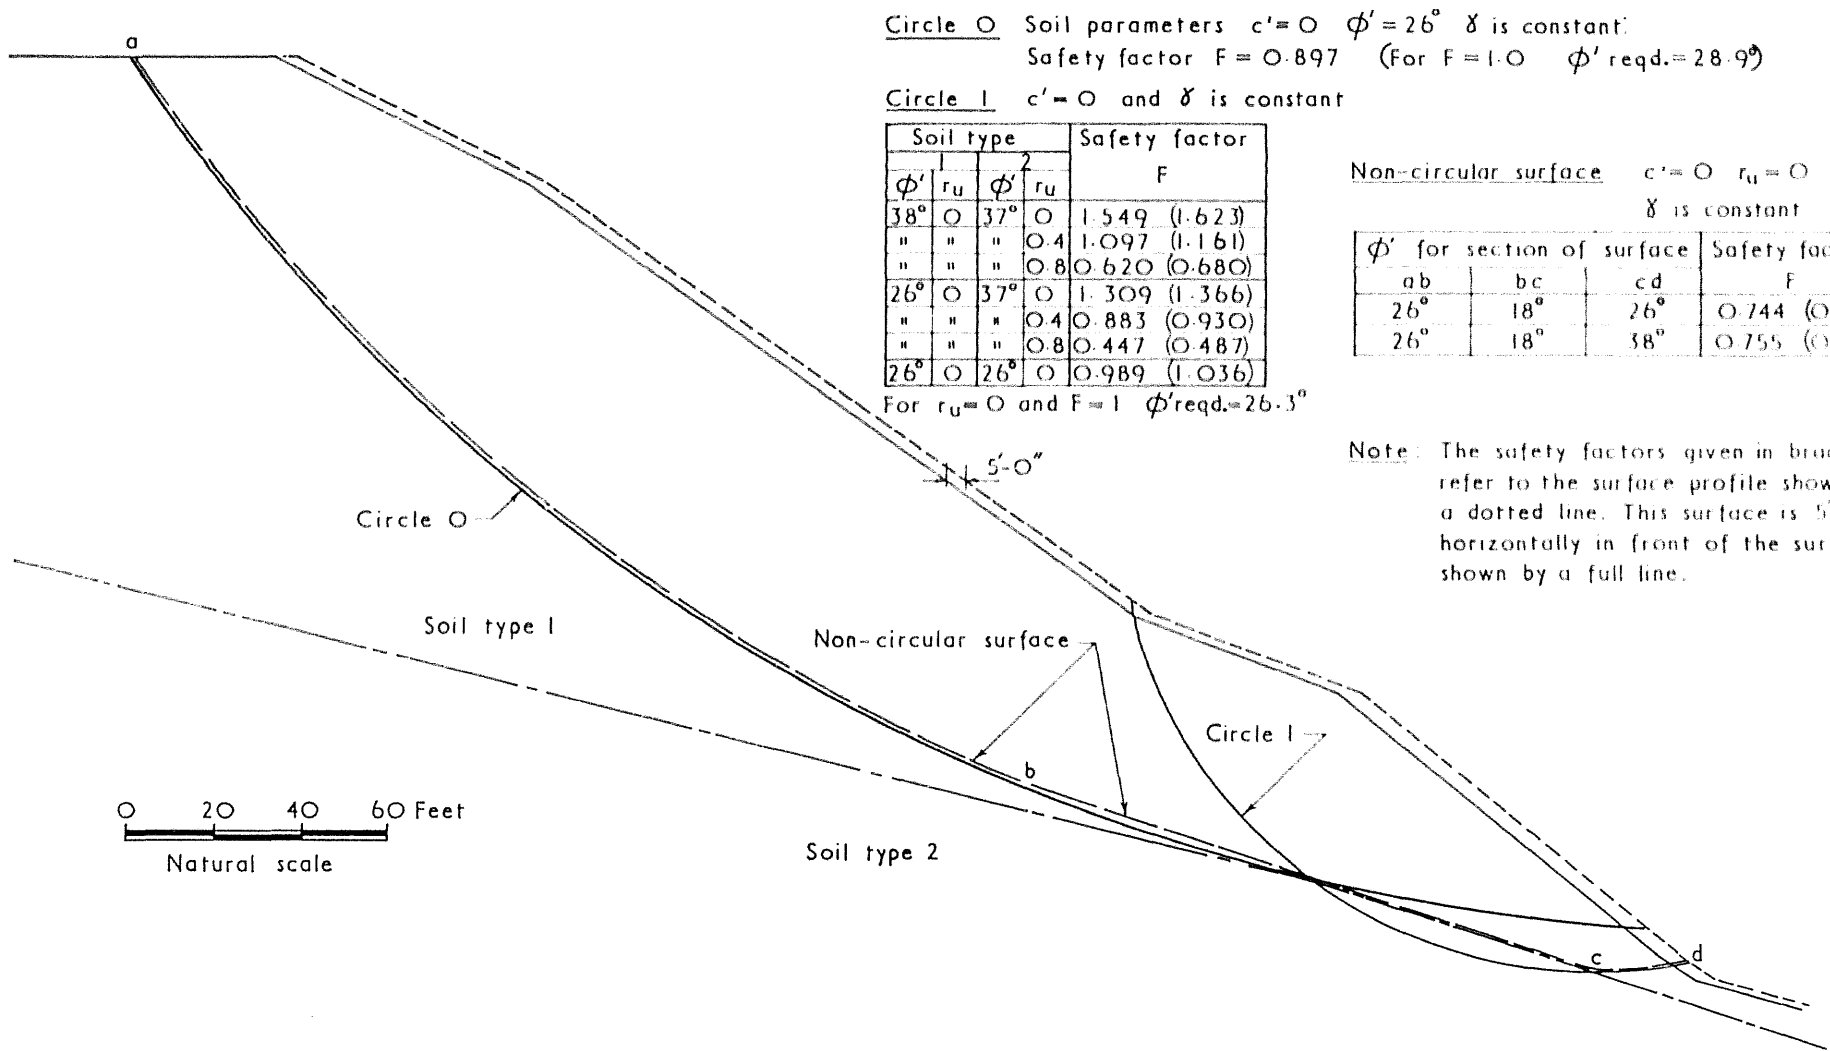
1.18 Failure surfaces assumed for the stability analyses of Tip 7.

Circle O Soil parameters $c'=0$ $\phi'=26^\circ$ δ is constant.
 Safety factor $F=0.897$ (For $F=1.0$ ϕ' reqd. = 28.9°)

Circle I $c'=0$ and δ is constant

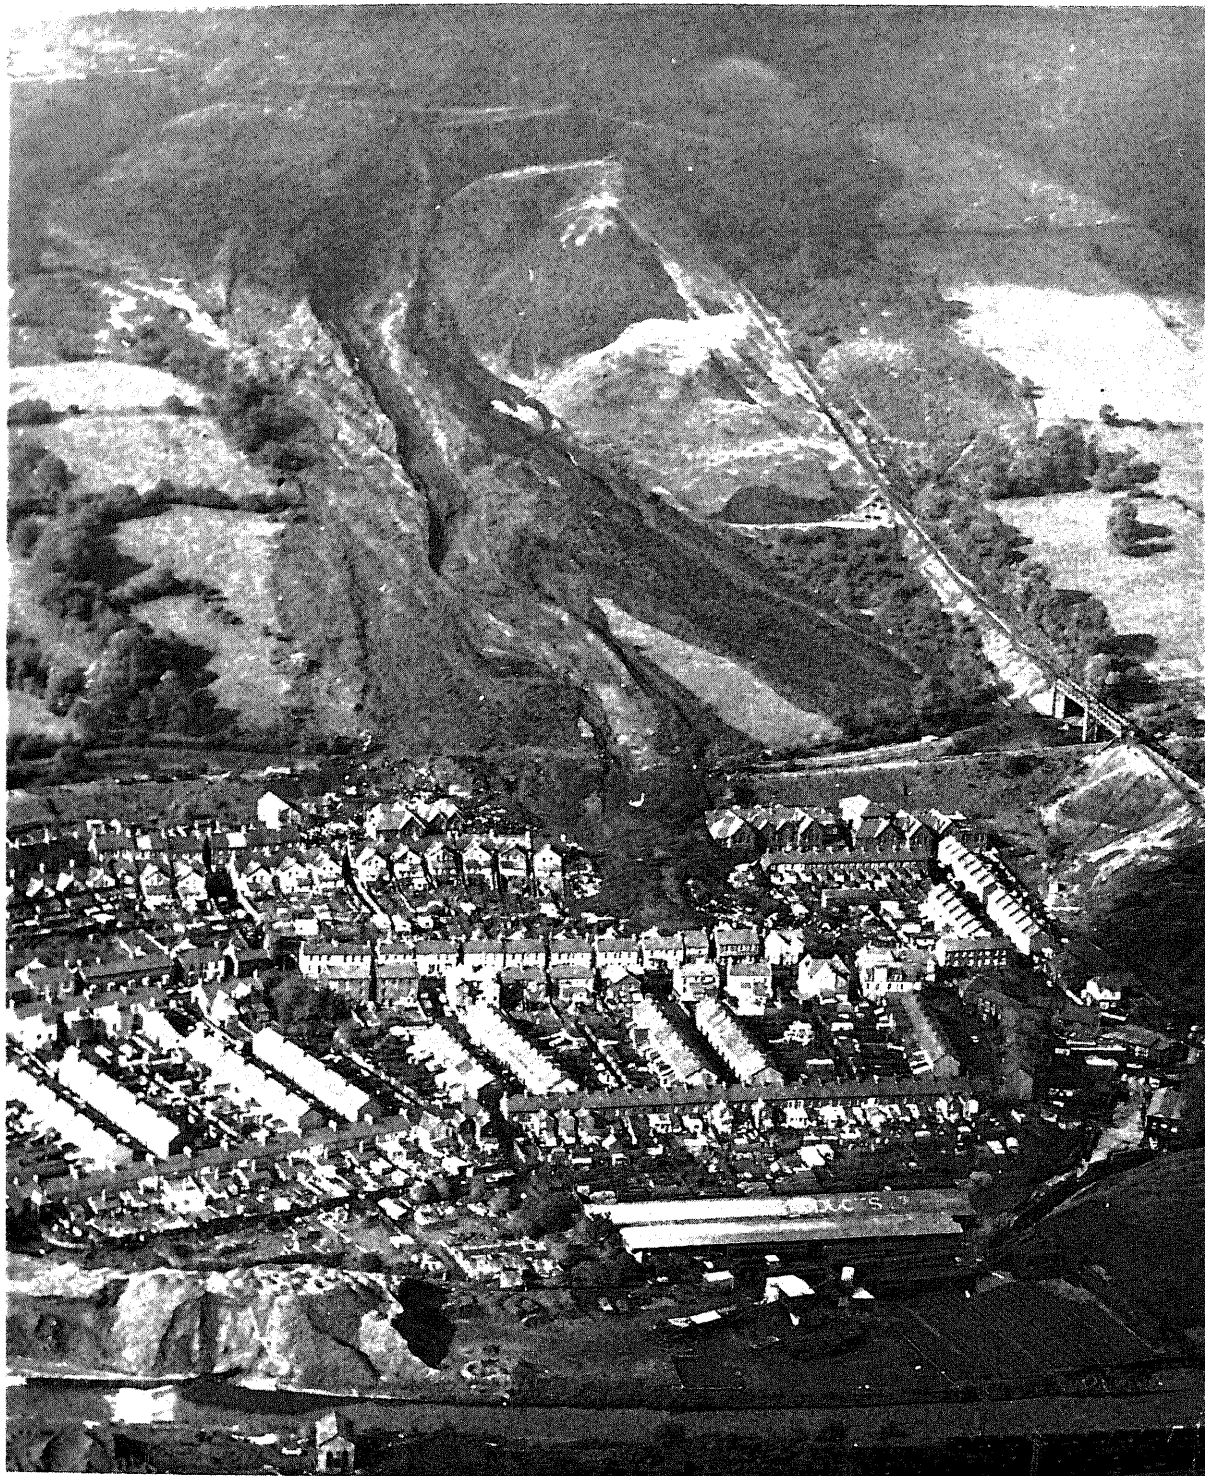
1.19 Photograph showing general view of flowslide and mud run. 21st October 1966, approx. 1 p.m.

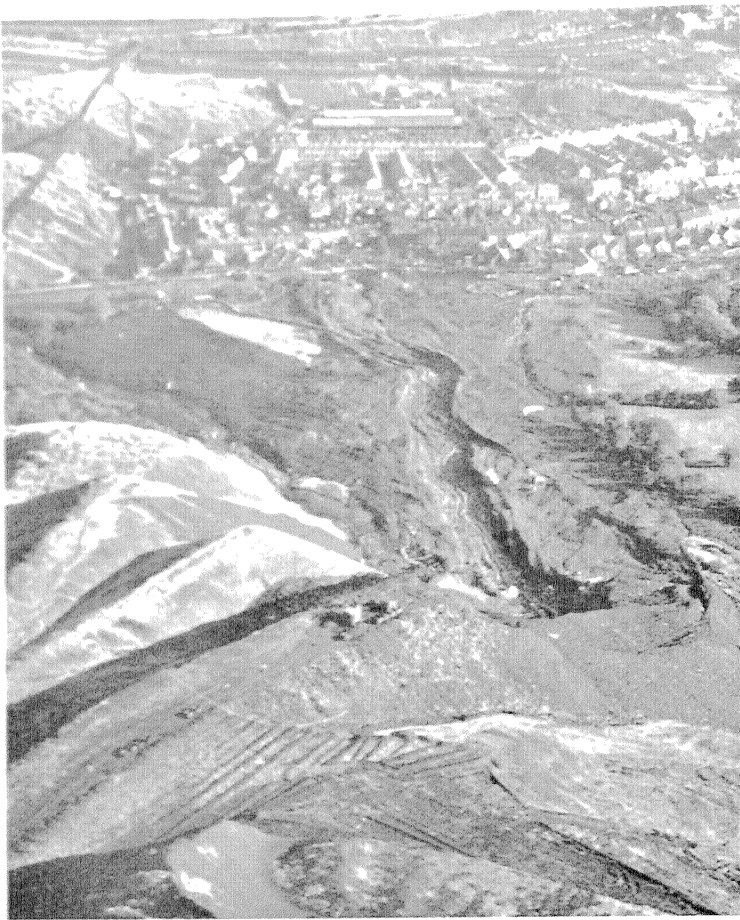
1.20 Photograph looking east showing course of mud run. 24th October 1966, approx. 2 p.m.

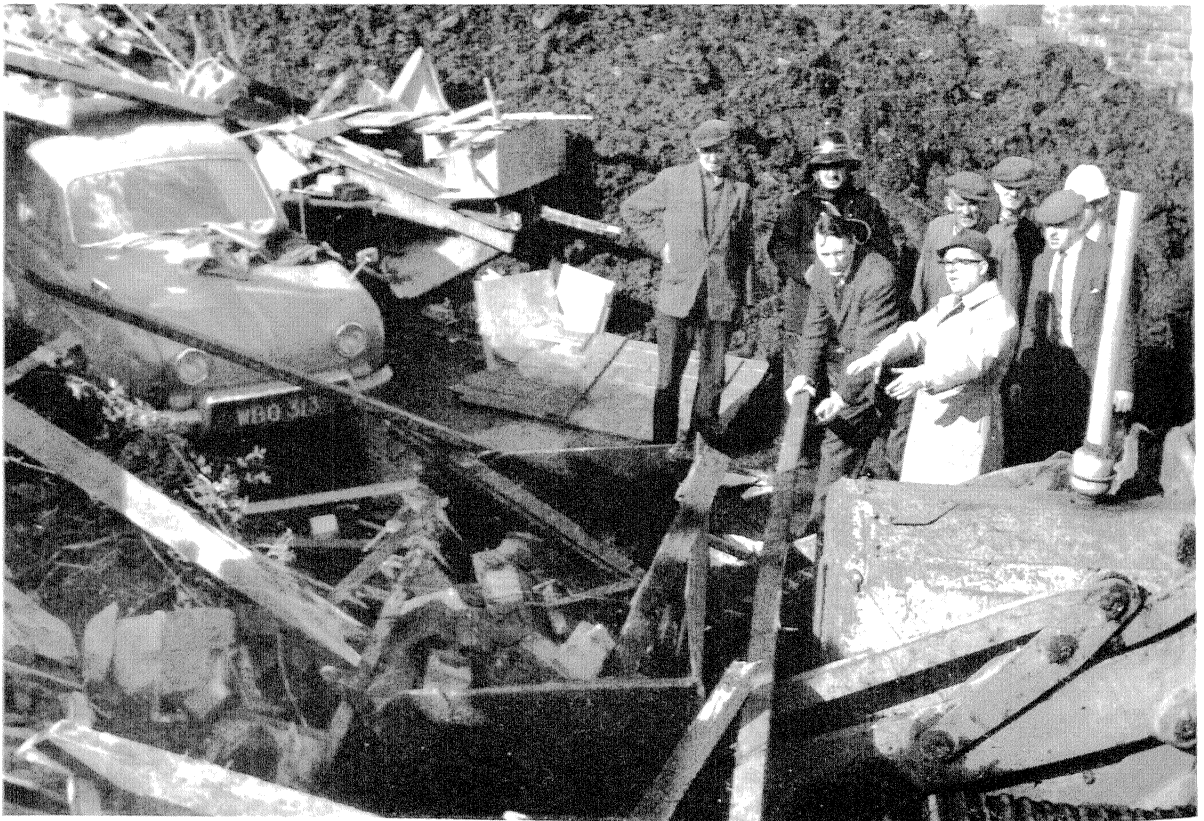
1.22 Photograph taken at approximately 11.15 a.m. on 21st October 1966 showing relatively 'dry' nature of rubbish with no indication of free water on the road surface.

- (3) The photographs showing the state of some of the material at the toe of the flow-slide indicate that it travelled without any great excess of water (Figs. 1.22 and 1.23). Fig. 1.24 indicates that within a few hours some areas of material were relatively dry and could be walked on without difficulty.

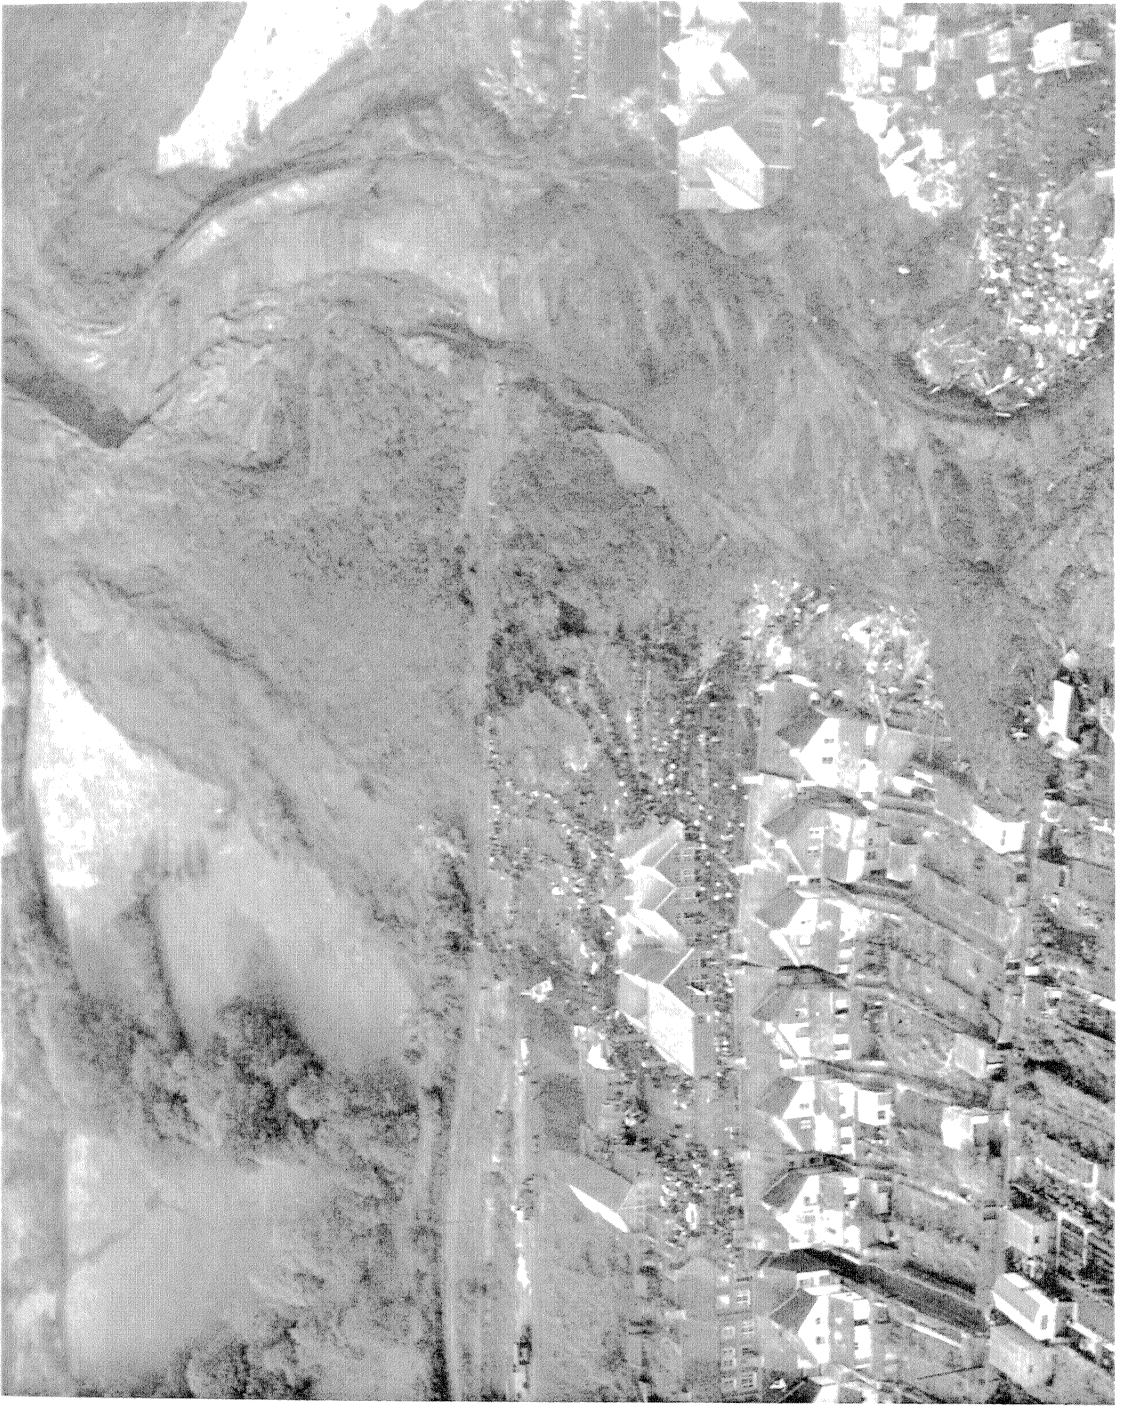
- (1) The toe of the tip broke away and travelled down the mountain-side at a considerable speed (probably between 10 and 20 miles per hour) followed by a large quantity of material having an apparently fluid consistency.
- (2) An examination of the photographs (Figs. 1.19 to 1.24) suggests that flow-slide material, i.e. material which has become 'fluid' due to the transfer of load on to the water already contained in its pore space, formed the initial phase of the flow of material which formed two branches on either side of the bare strip of land above the Senior School. The southern branch of this fork appears to have been primarily responsible for the destruction of the Junior School (Fig. 1.21).

1.21 Photograph giving a localised view in area of Junior School and showing alignment of flowslide towards this school.
21st October 1966, approx. 1 p.m.

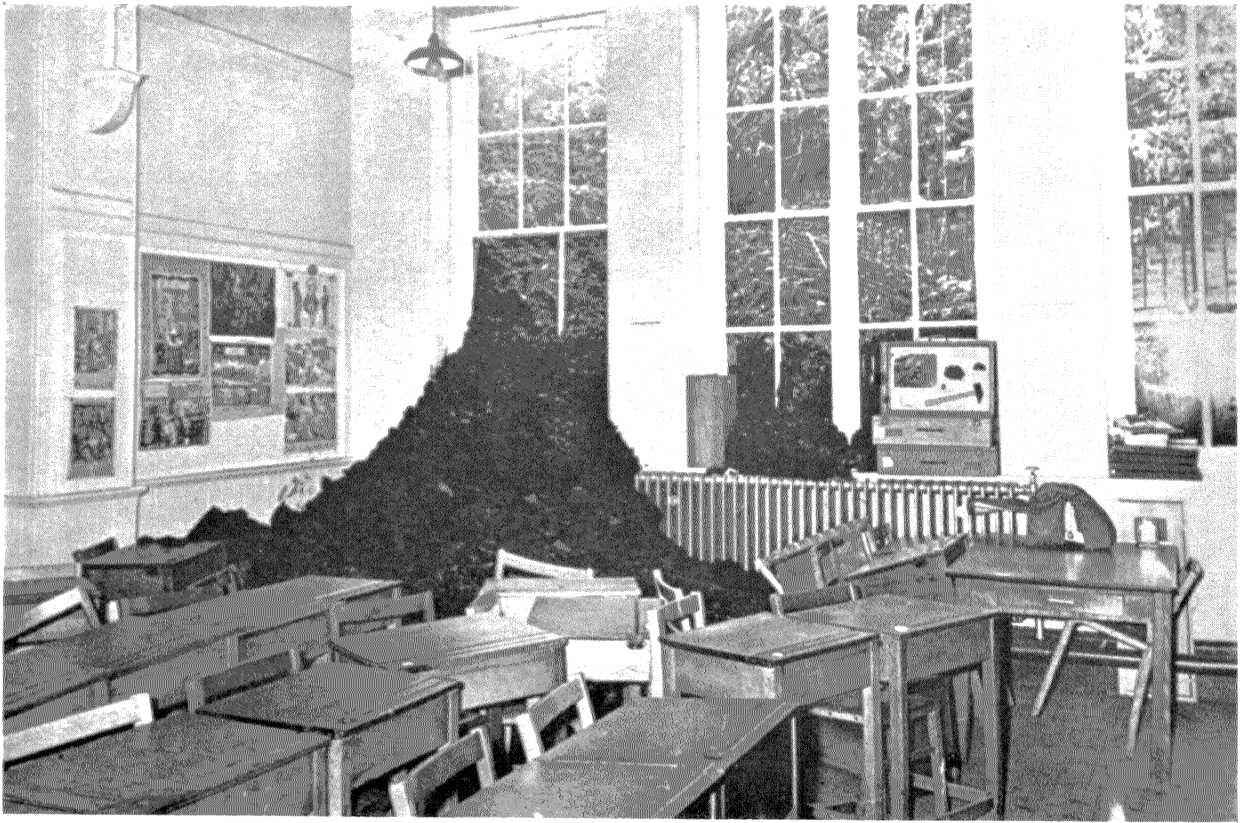
1.23 Photograph showing a mound of rubbish in the corner of a classroom in the Senior School with no indication of free water.

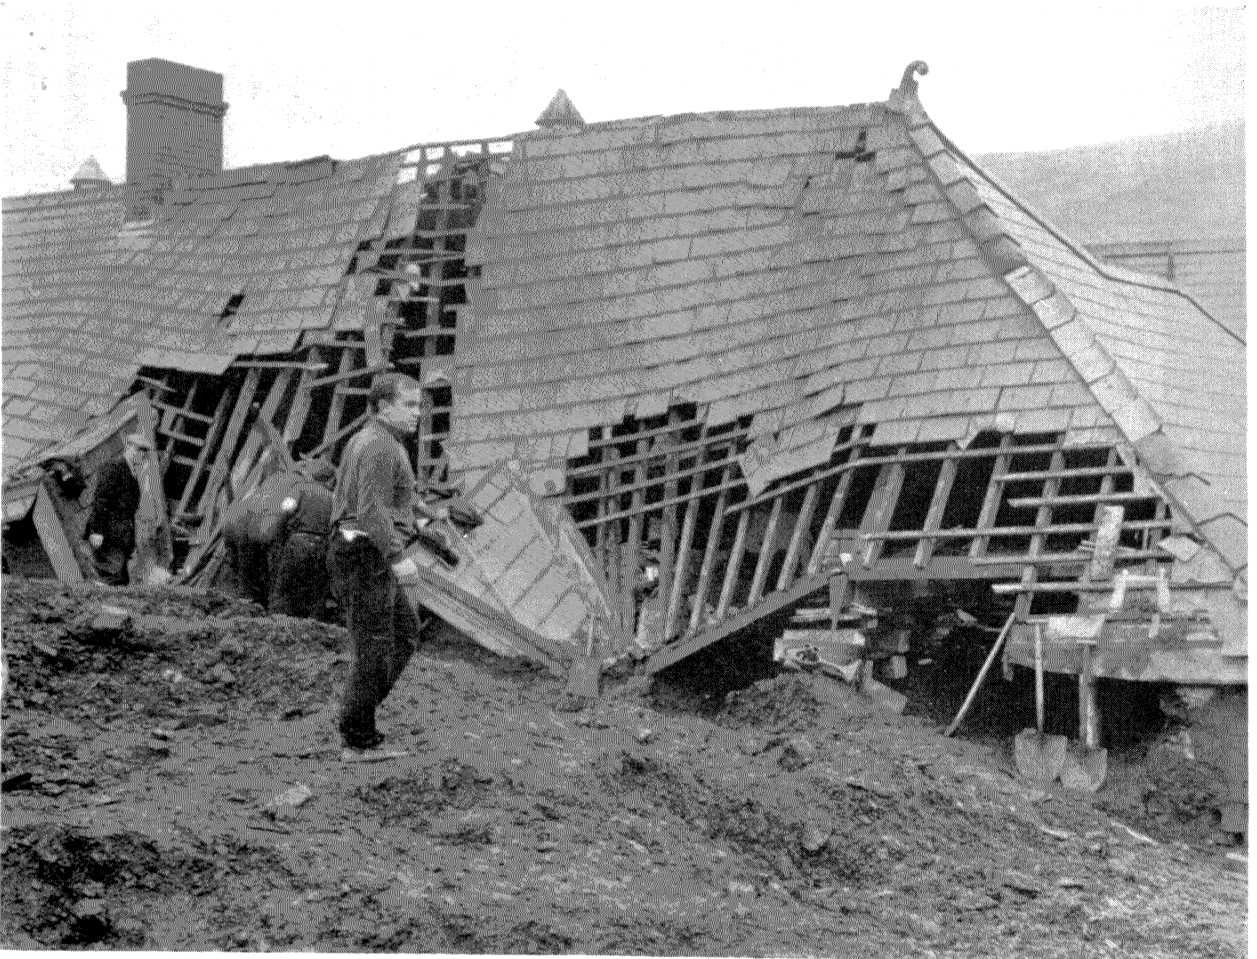
1.24 Photograph showing rubbish at rear of Junior School at approximately 3.30 p.m. on 21st October. Person in light-weight shoes is able to walk across this material without difficulty.

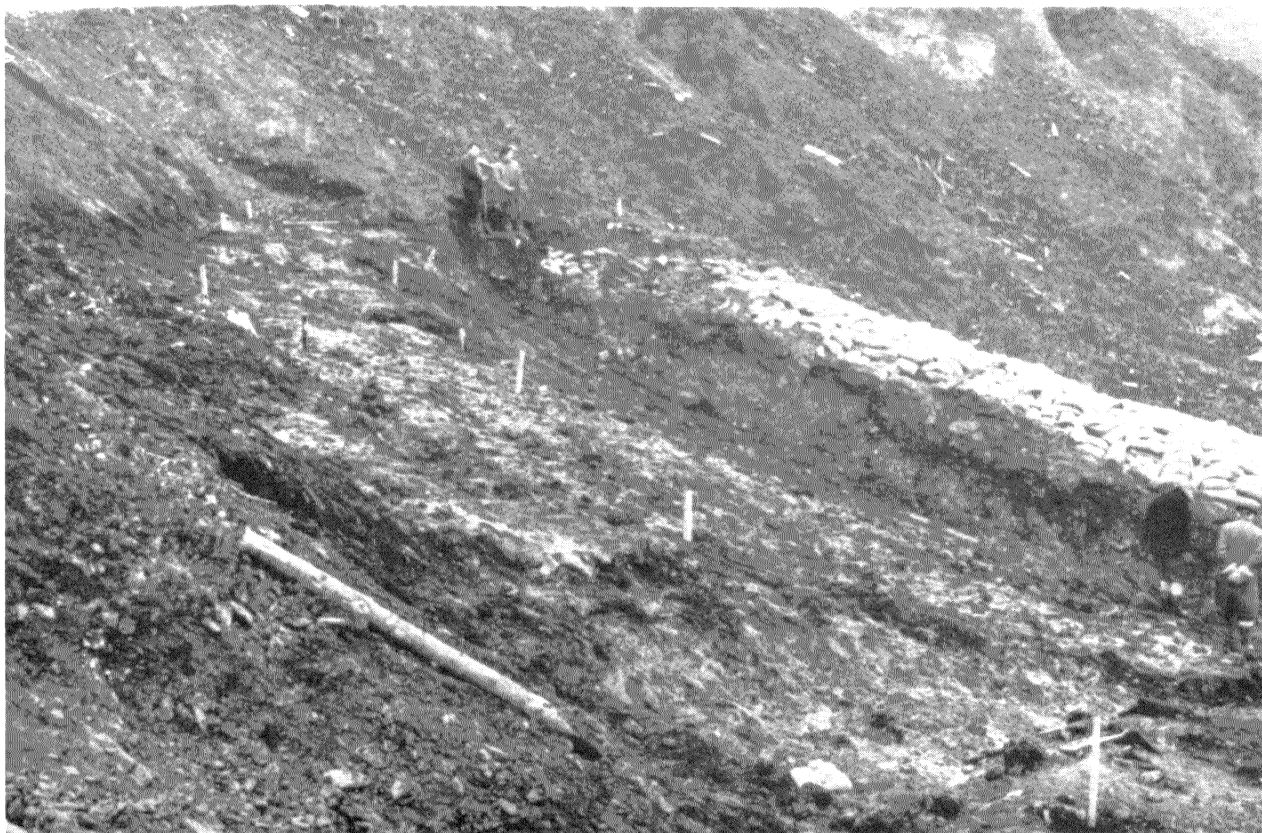
1.25* Colour transparency showing bowl in natural ground left by the slip. The pegs mark original ground surface.
